Product/Service Information

CHEMISTRY AND STONE

2011/12-1

Innovative Composites Pty Ltd

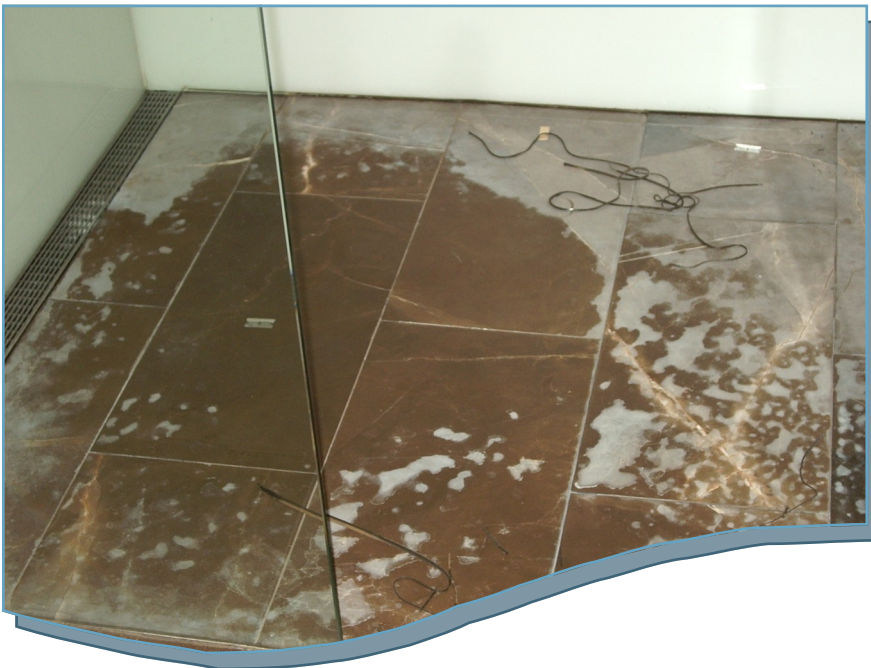
Example of efflorescence

Efflorescence appears as a white powdery residue on the surface of the stone. It is a common condition on new stone installation or when the stone is exposed to a large quantity of water, such as flooding. [Shower floors] This powder is a mineral salt from the setting bed. The stone will continue to effloresce until it is completely dry. The drying process can take some time to dry naturally.

After removing the efflorescence from the surface and drying the affected area. The surface can be coated and sealed with CLEARSTONE™ to prevent efflorescence from happening again from flooding on the surface. Any moisture that may continue to come from beneath the stone 'osmosis' would need to be addressed.

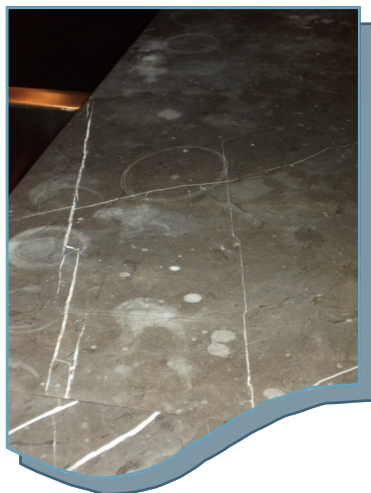
Example of etching, water rings/spots

Water rings and spots are common on marble tops where 'hard water' is left on the surface and allowed to dry on the surface. This is water that is rich in minerals such as calcium and magnesium and when the water evaporates it leaves behind these minerals forming rings or spots.

Coating with CLEARSTONE™ will prevent water rings and spots along with removing the need to strong alkaline cleaners.
